# Prepurchase House Inspection

T.H.I.S. South & East Wellington Ltd

Wed 15 May 2019

**91 Buckley Road, Southgate, Wellington, 6023, New Zealand**

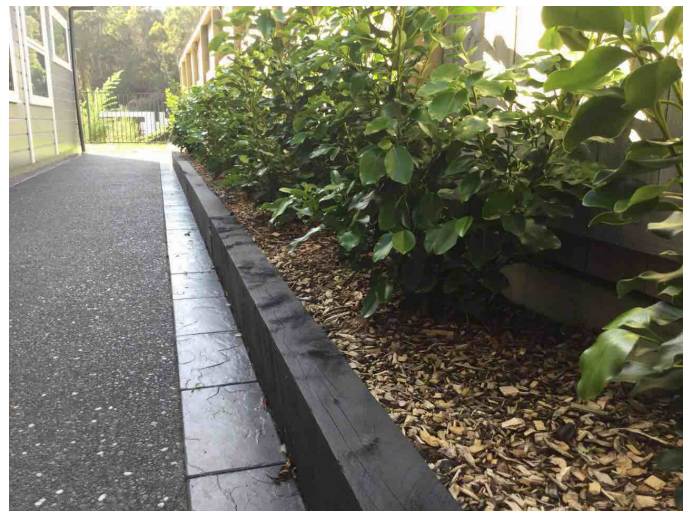
Low maintenance grounds, paved surfaces, low maintenance gardens, and fully fenced. No significant concerns.

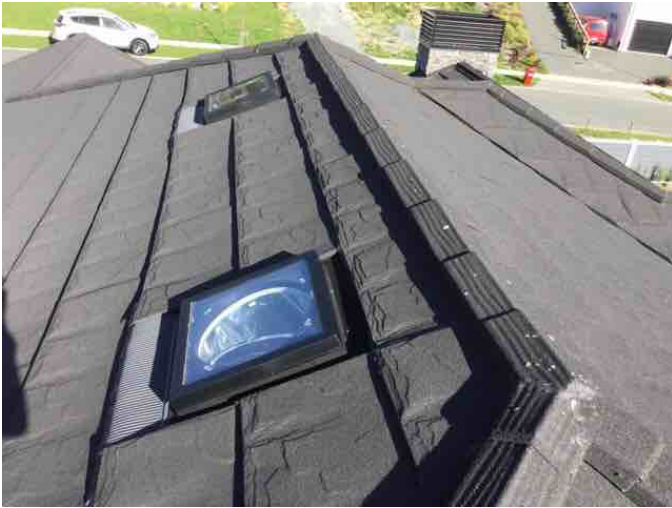
Decramastic tile roof.  
No concerns.

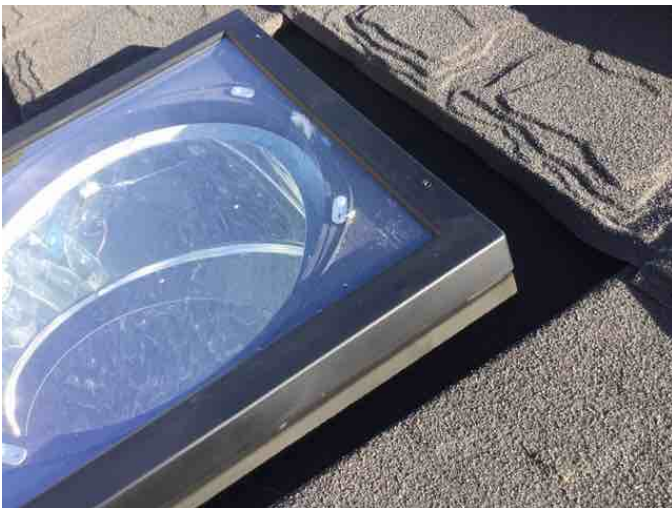
Anually inspect all penetrations. Potential debris build up, behind the flashings can cause moisture ingress.  
No concerns sighted.

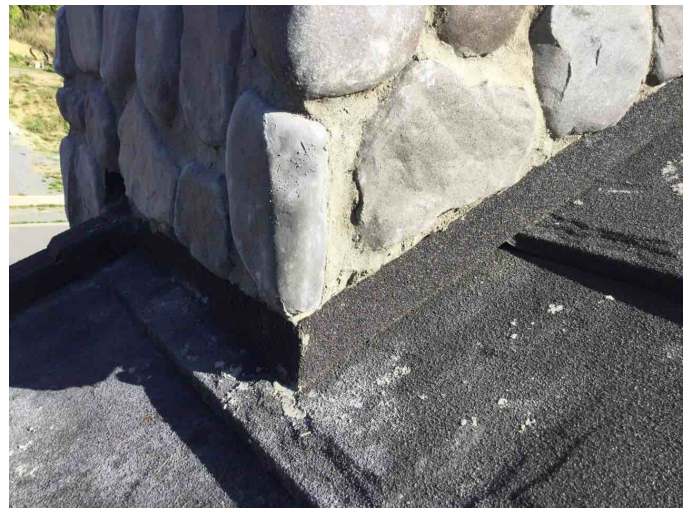
Dummy chimney flashing well detailed. No significant concerns. Mortar residue is evident on some of the roofing tiles.

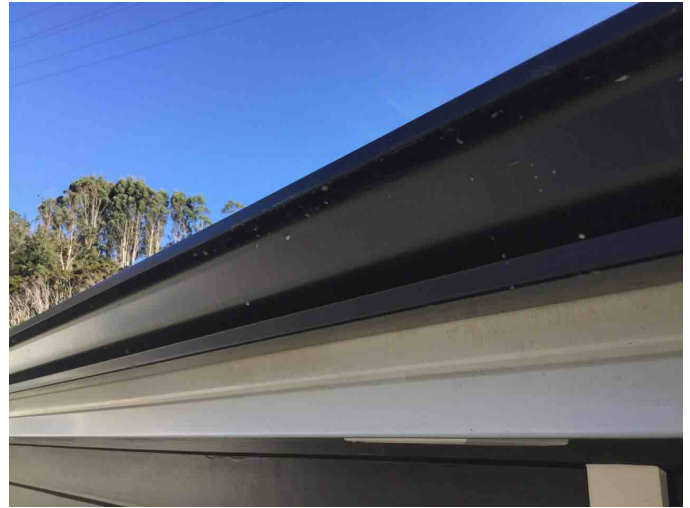
Metal spouting system and pressed metal fascia. These systems are generally low maintenance and robust. Recommend washing at least twice yearly to remove grime build up which slowly deteriorates the paint coat.

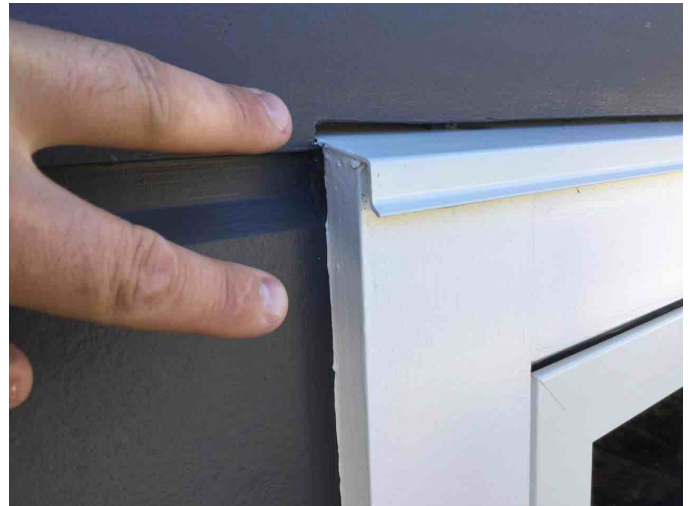
Example. Headflashing, and well sealed timber detailing sighted throughout. No concerns.

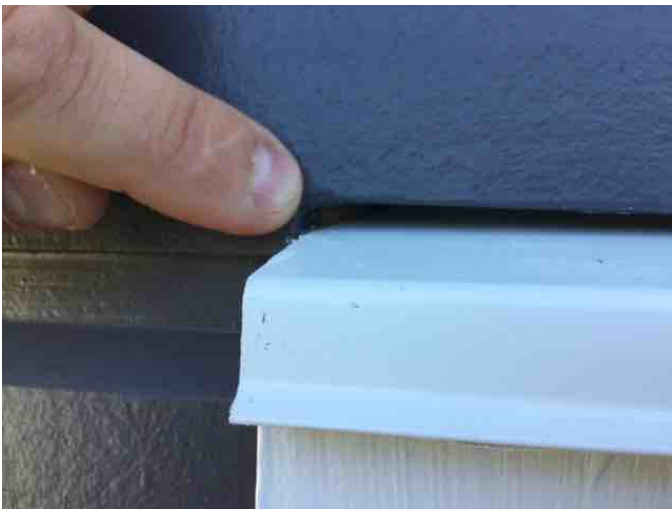
Noted, I sighted a silicone seal up under the top corner, to prevent wind driven moisture ingress.  
Good detailing noted.

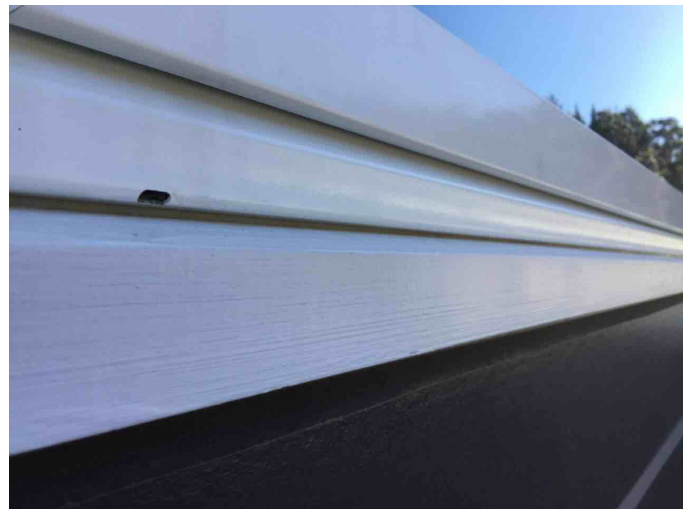
Timber sills well ramped to deflect surface water from ponding. Timber detailing is more susceptible to paint deterioration, particularly in higher exposed faces.  
Recommend maintaining a thorough paint coat seal, to prevent timber deterioration.

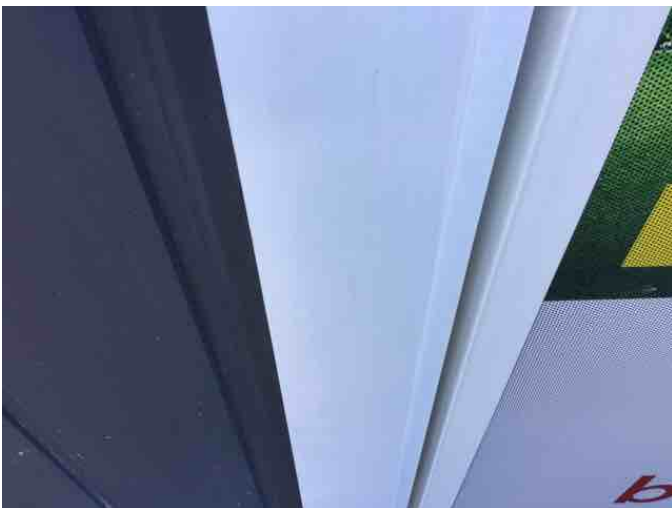
Noted. Isolated areas of timber trim, where the paint coat is thin in areas.  
This section is around the garage door.  
No significant concerns.

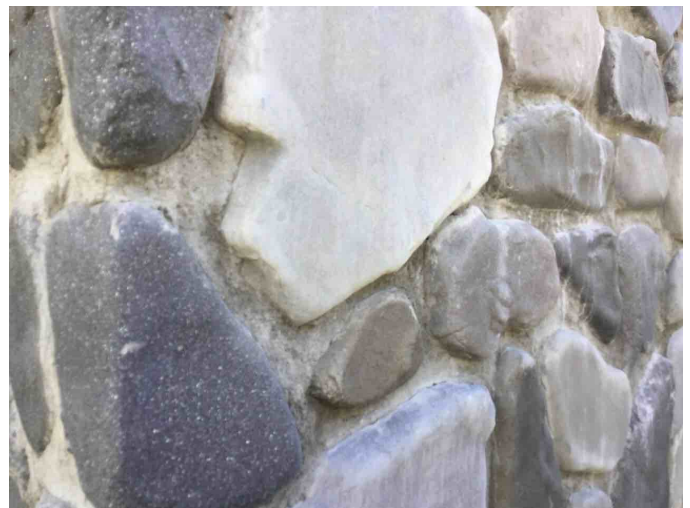
Classic stone veneer, cladding the chimney. Installed to a good standard. No concerns.

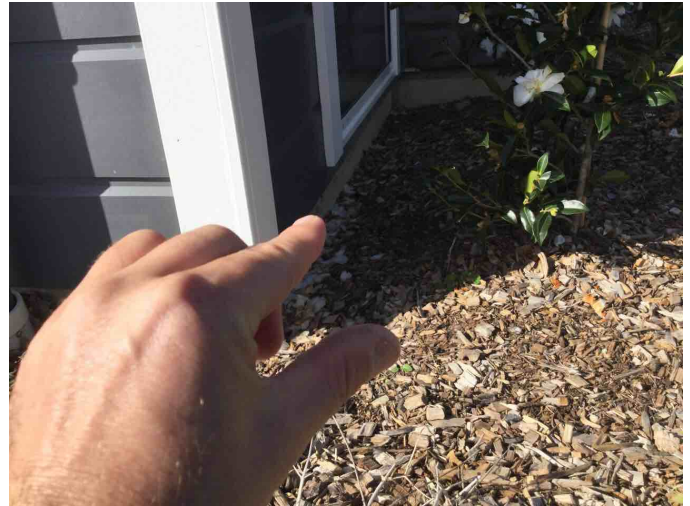
Maintain adequate ground clearances around the perimeter of the home. No concerns.

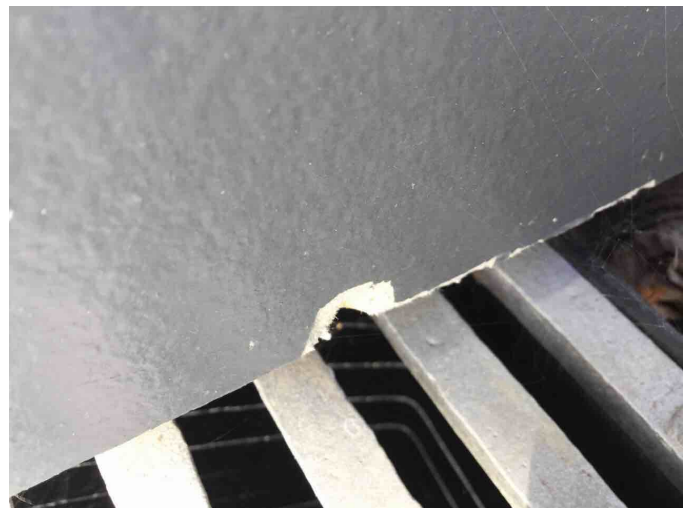
Example, noted in isolated areas. Small chips and concrete residue. Maintain a thorough paint coat seal to all cladding.

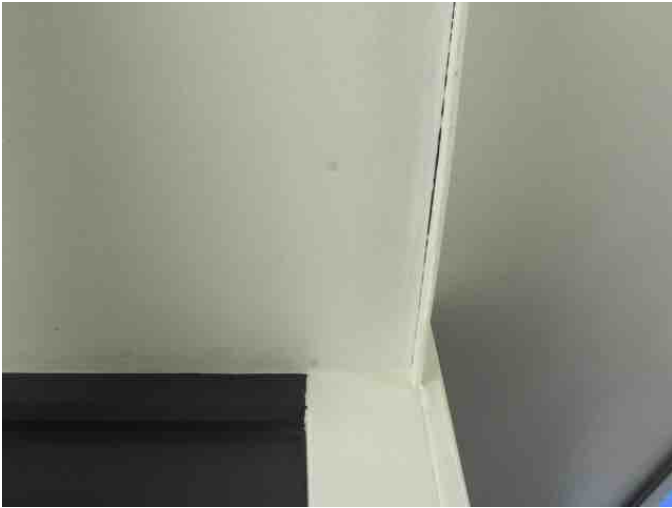
Noted around the soffit. Paint coat thin in areas.  
No significant concerns.

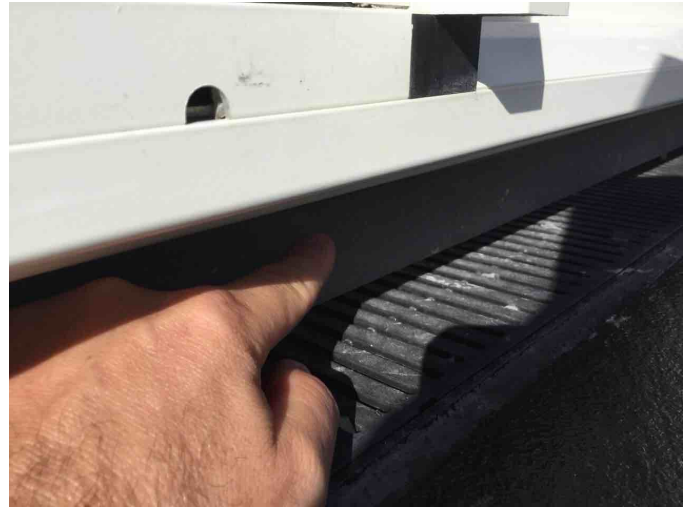
Noted. The section of cladding under the sliding aluminium door is floating, and could easily be knocked and broken.  
Recommend fixing it back to the foundation.

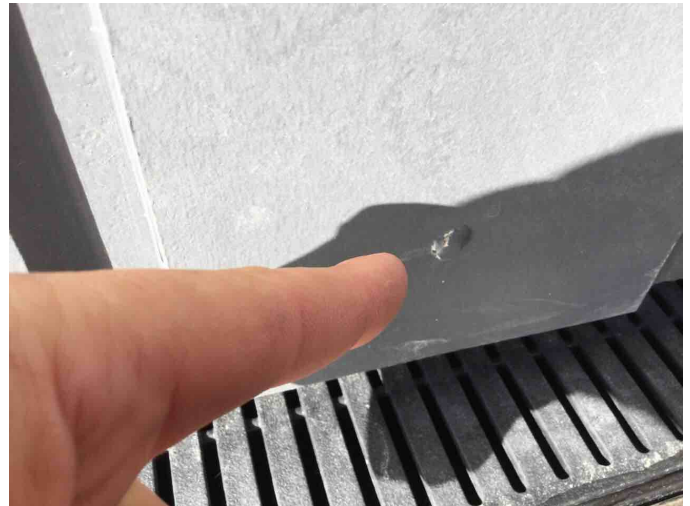
Noted. Slight popped fixing. Mainly cosmetic, no significant concerns. Small remedial required.

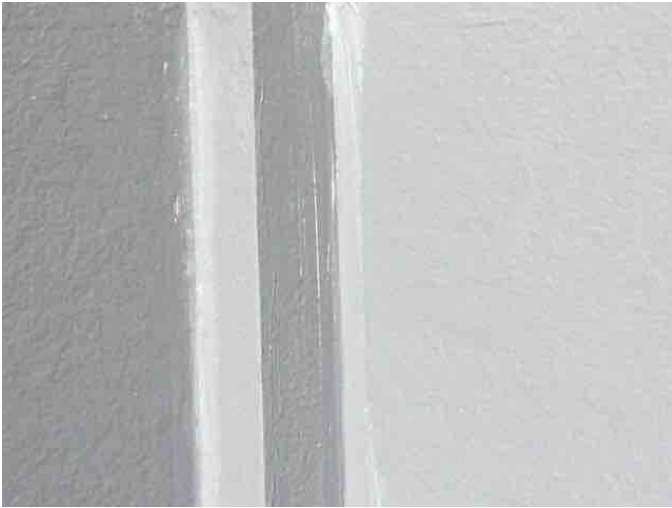
Example, some timber detailing has a thin top coat.

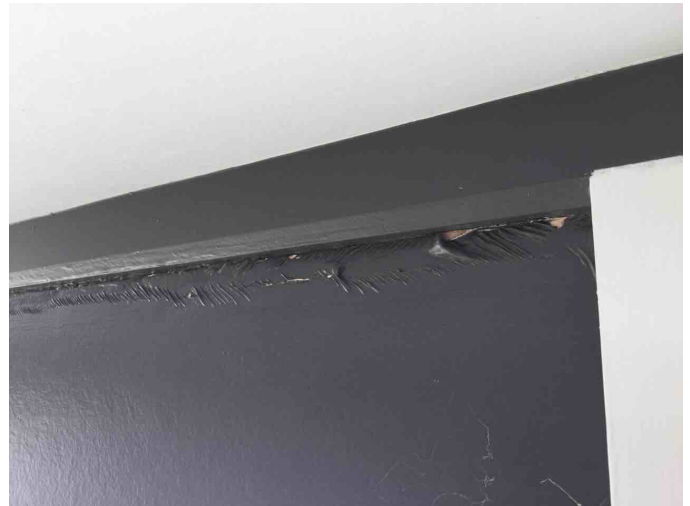
The paintcoat has significant defects adapting the timber trim / soffits Remedial work is required to maintain the paint coat integrity.

The paintcoat has significant defects adapting the timber trim / soffits

Remedial work is required to maintain the paint coat integrity.

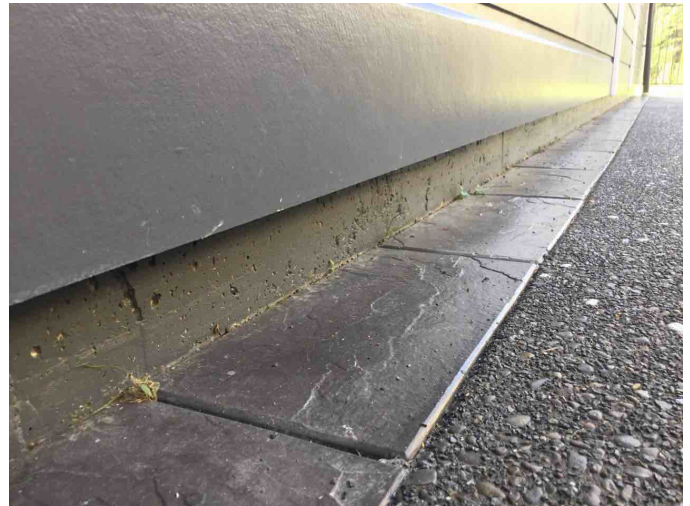
Good ground clearance noted.

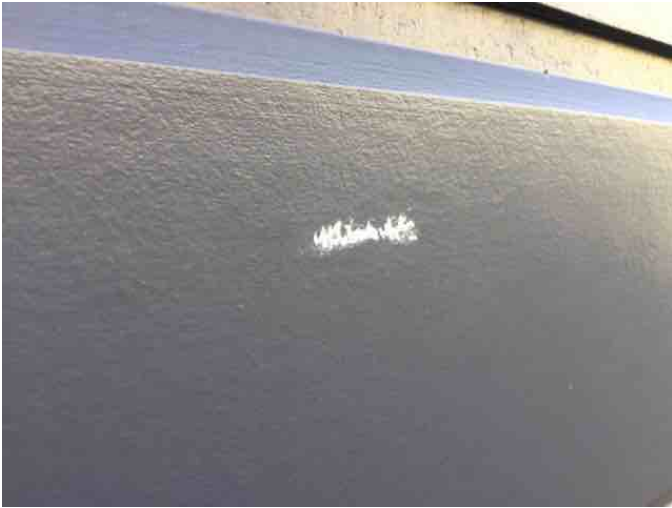
Example. Slight paint defects. Generally cosmetic. Recommend isolated remedials.

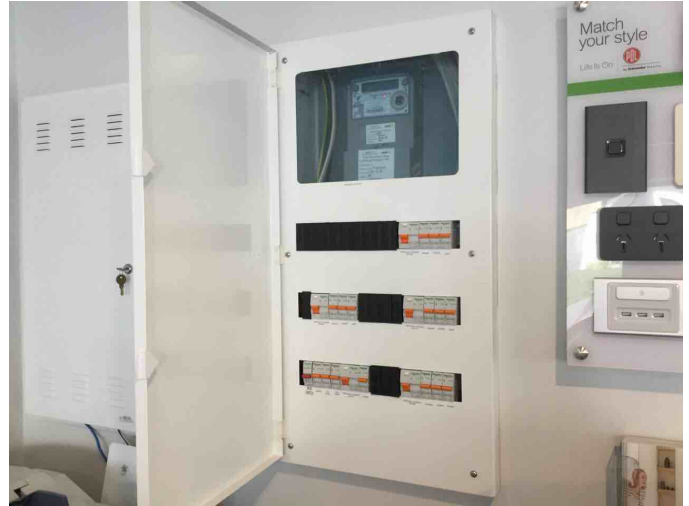
Switch board. No concerns.

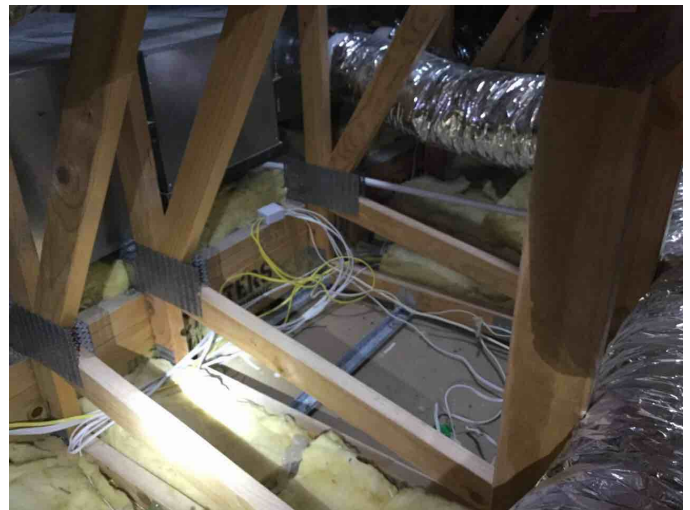
Noted. Some isolated areas where the insulation has been removed. Recommend re fitting in these areas.

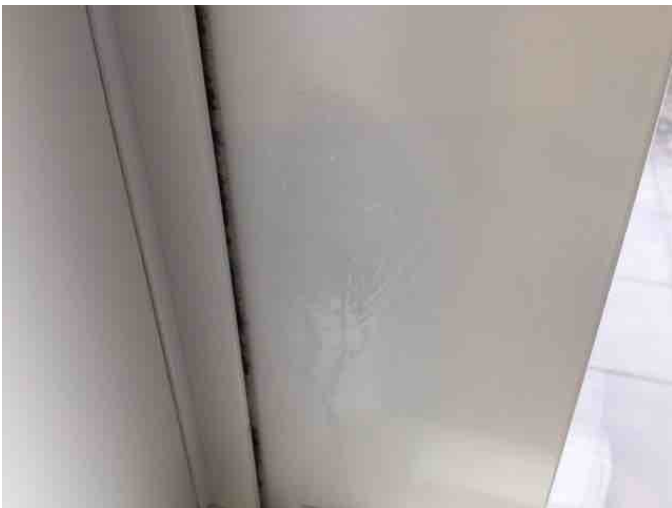
Plaster or some residue sighted on the sliding door.  
No significant concerns should wipe off.

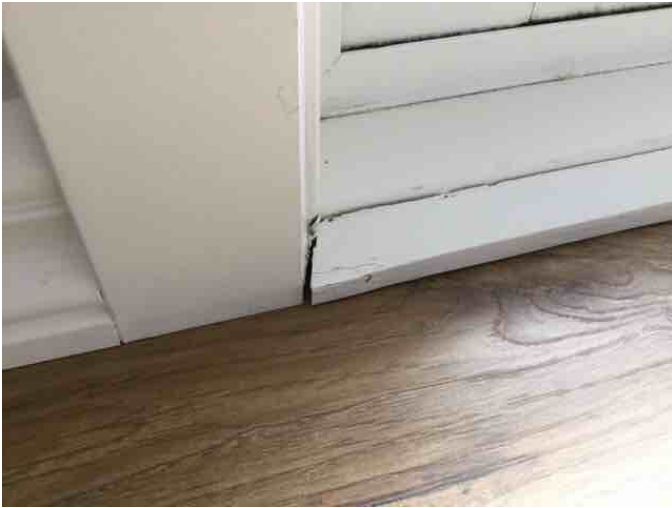
Noted. Slight cosmetic defect in the finish of the timber trim.  
No significant concerns.  
Keep well paint coat sealed.

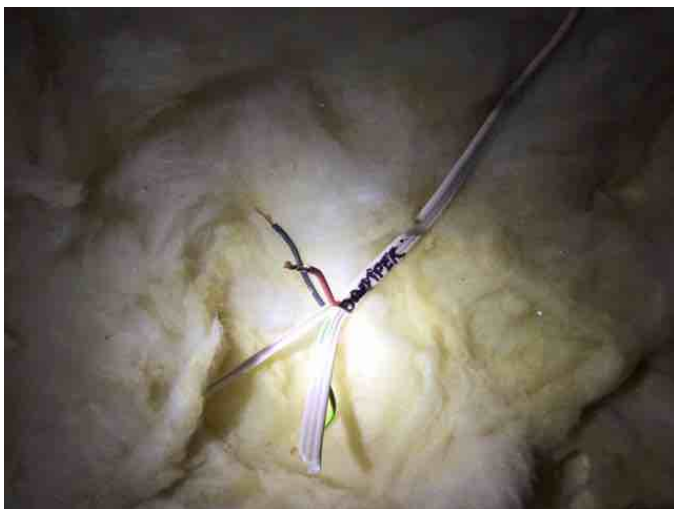
Open ended wire sighted in the ceiling cavity, unsure as to its purpose.  
Recommend becoming familiar with the electrical system in the home.

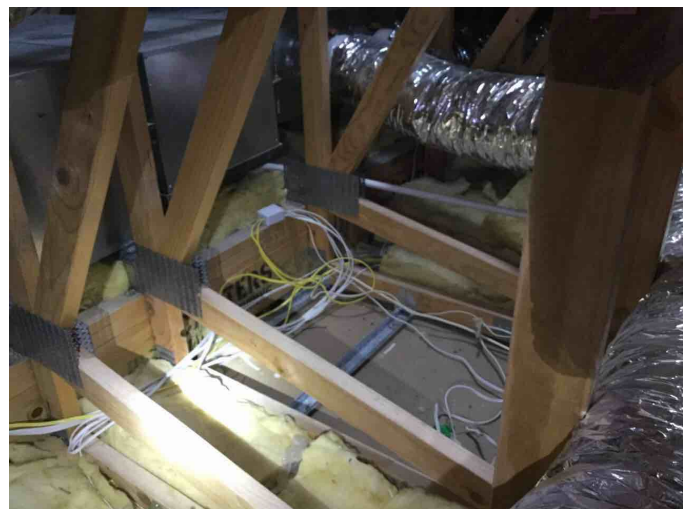
Noted. Some isolated areas where the insulation has been removed. Recommend re fitting in these areas.
