# Prepurchase House Inspection

T.H.I.S. South & East Wellington Ltd

Wed 15 May 2019

**91 Buckley Road, Southgate, Wellington, 6023, New Zealand**

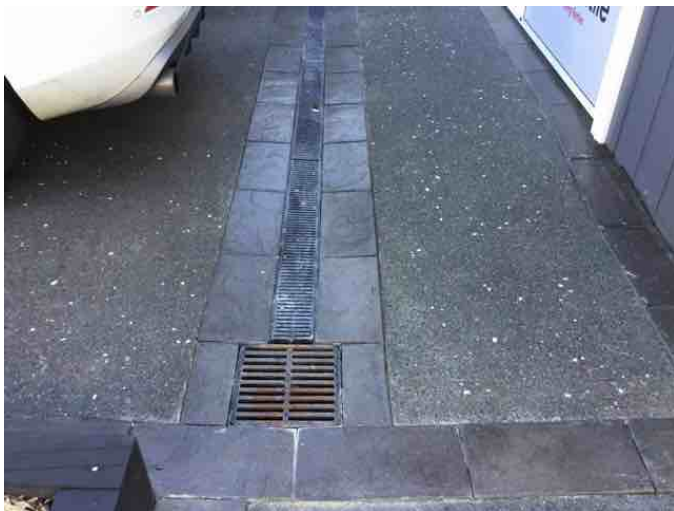
(Surface water control) the slope of the driveway mostly, fall toward the garage. This is allowing for the natural flow of surface water, toward the building.

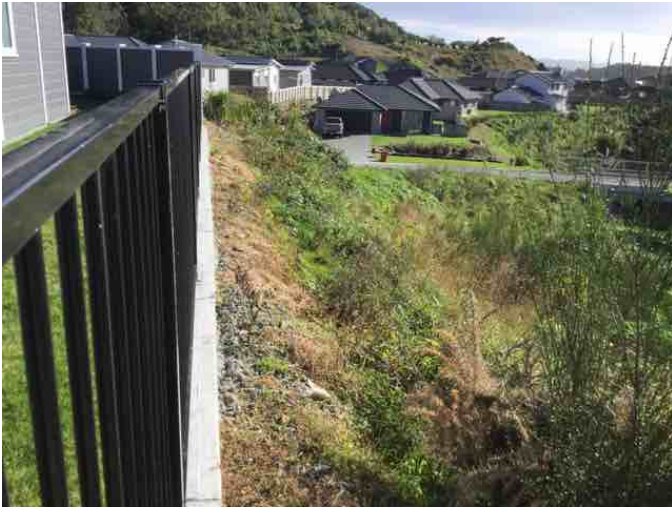
The rear of the section adjoins a bank, which slopes away from the home.  
No evidence of subsidence sighted.

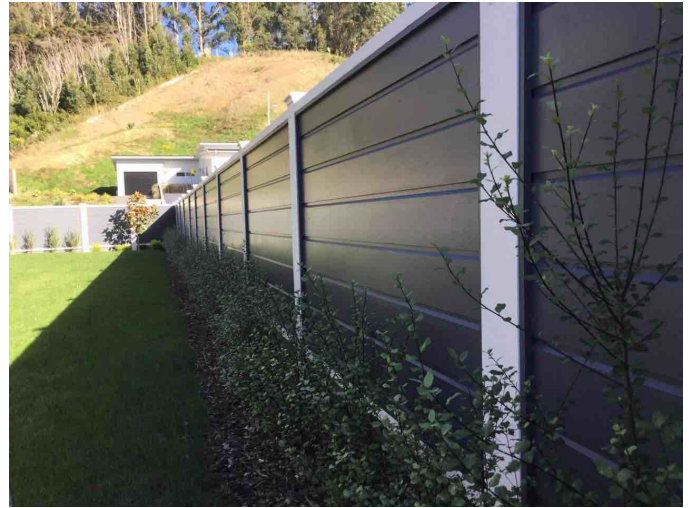
Fully fences section, the fencing is well spec'd and detailed. Consideration should be given to the planting, and how the fence can be painted, and maintained in the future, if vegetation is up against it.

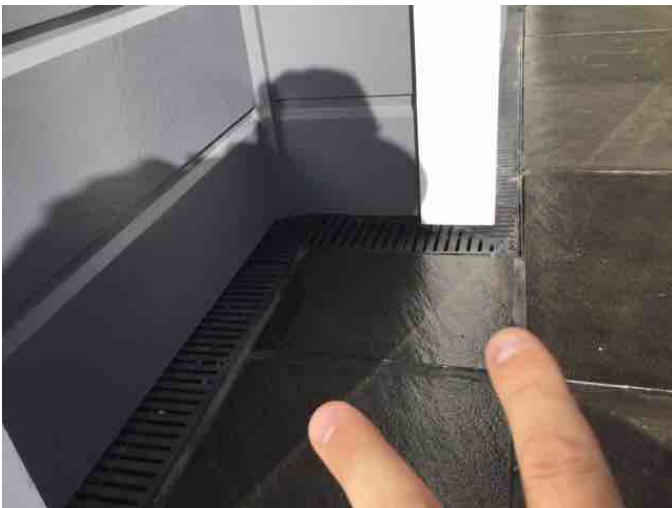
Due to the high paved ground level, a channel grate surface water collection system has been installed. Regularly clean out to maintain the free flow of surface water within the channel.

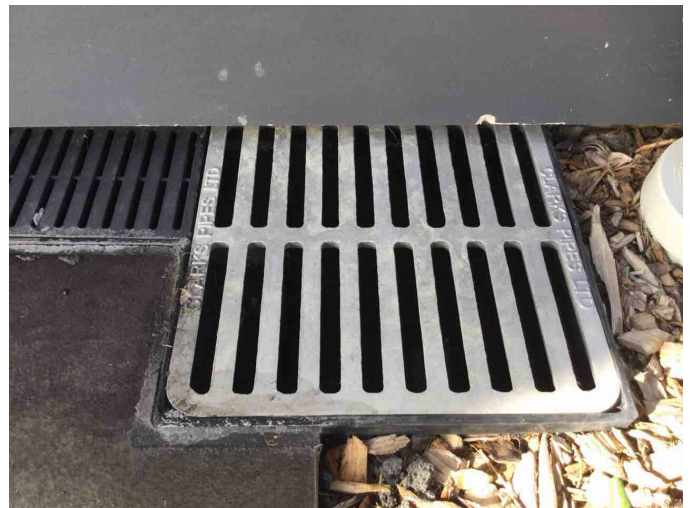
Regularly clean out debris from the surface water sump, they are a interceptor trap, to prevent debris entering the stormwater drainage system.

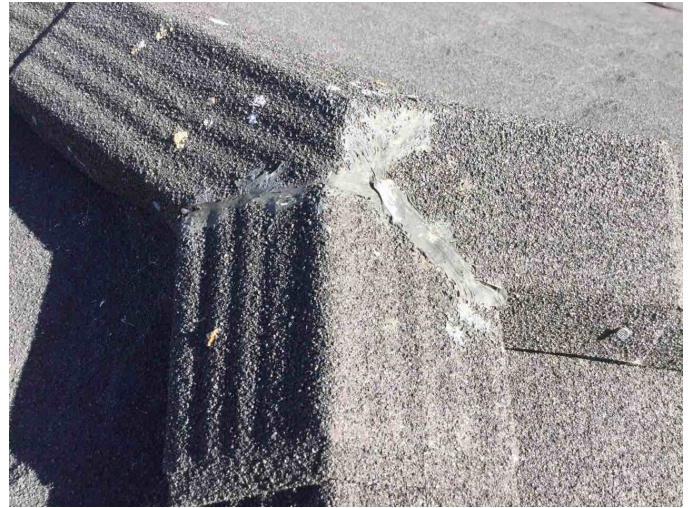
Complex junctions well detailed.

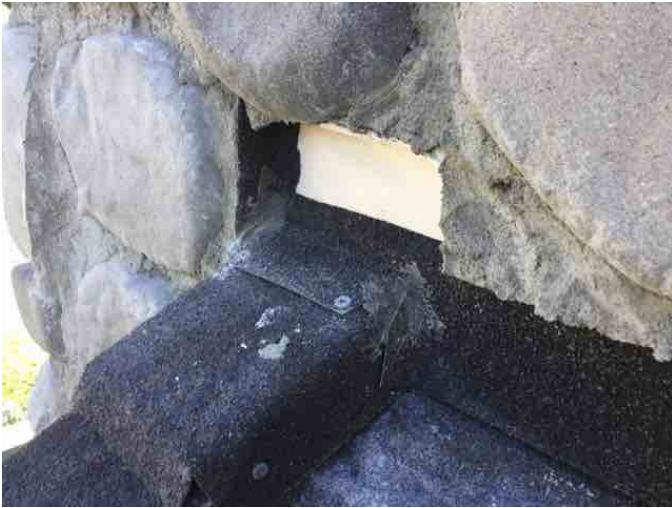
Example. Annually inspect all silicone seals around complex junctions.

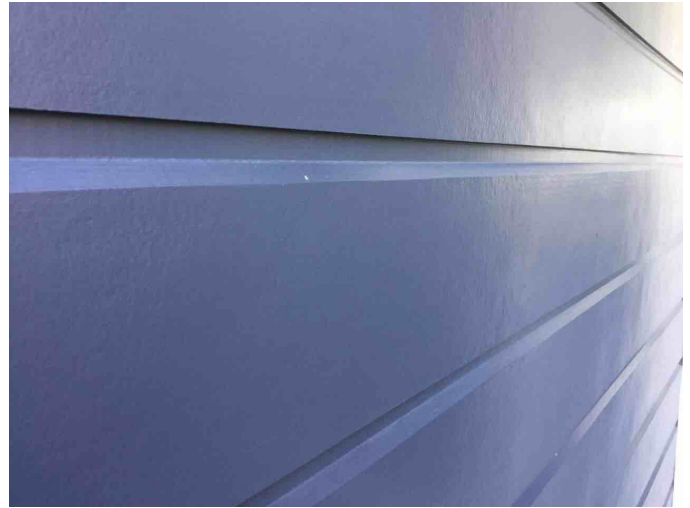
The weatherboard has a Resene 3 coat paint system as verbally communicated by show room staff.

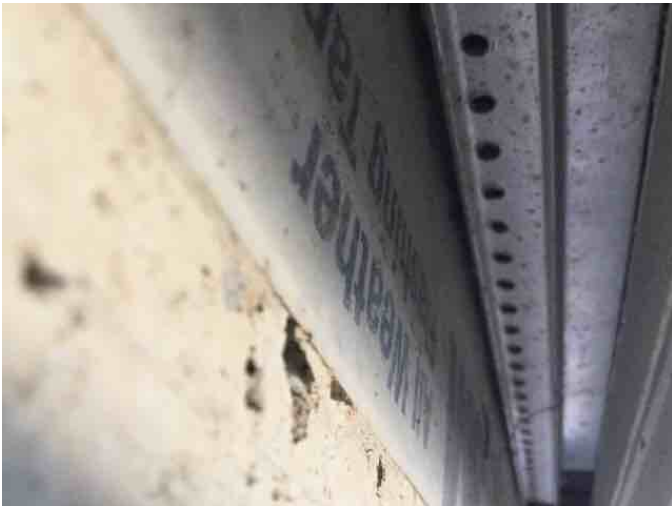
The cladding has been fixed over a Cavity batten system. This allows any potential moisture ingress, to ventilate and dry out.  
Good detailing.

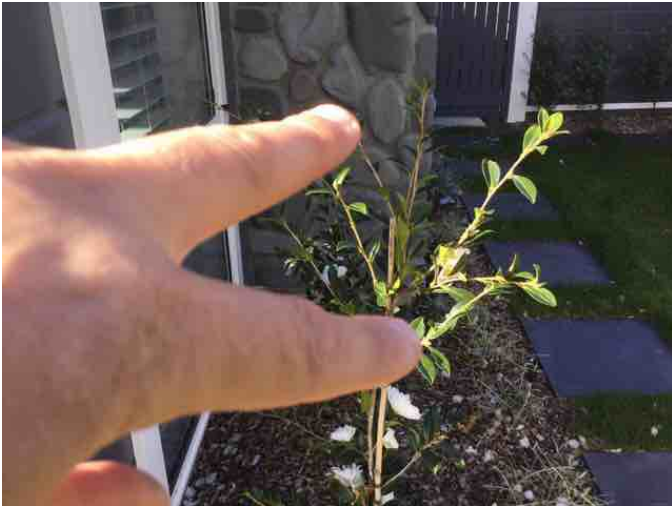
(Future proofing) It's not advisable to have vegetation up against cladding. This speeds up deterioration of painted surfaces, recommend regular pruning to maintain a reasonable air-gap separation between the growth and the cladding.

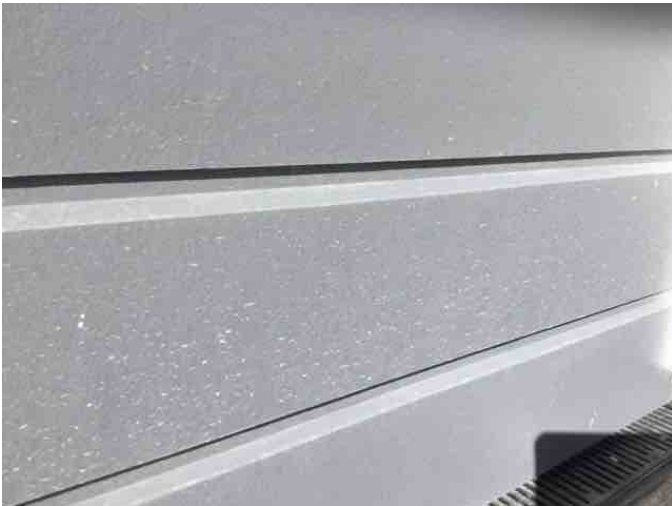
Sighted, residue to parts of the cladding, possibly from the concrete placement. Check to see if this can be washed off.

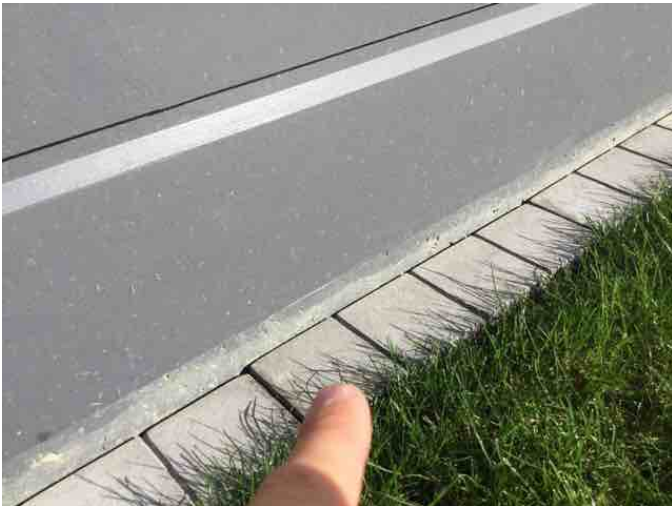
Consider mortaring the mowing strip in place.

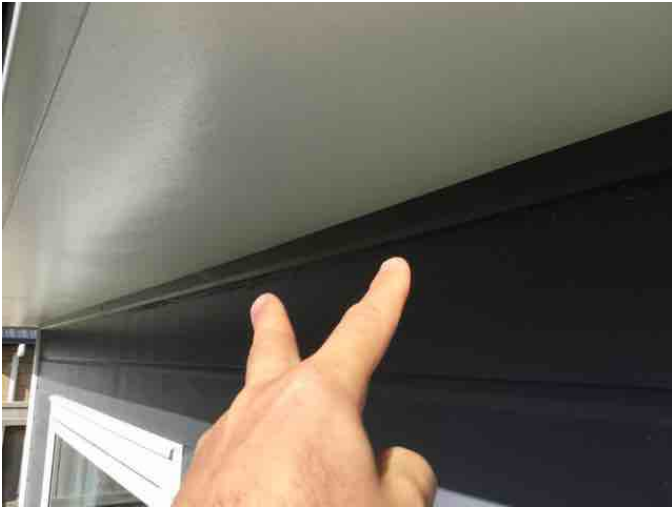
Sighted in this area.

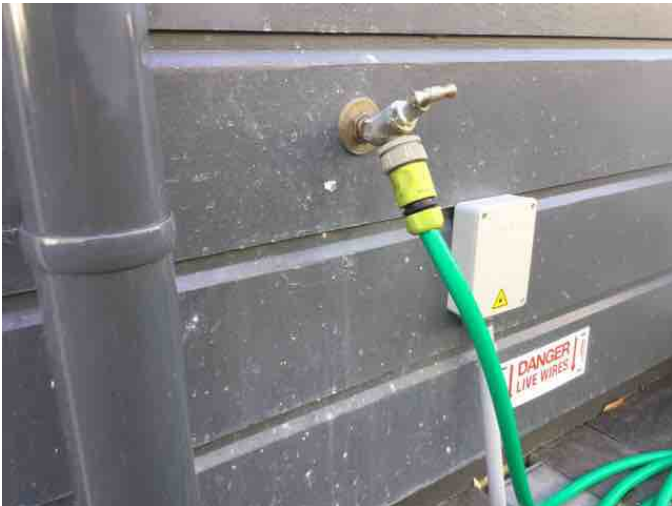
Sighted, residue to parts of the cladding, possibly from the concrete placement. Check to see if this can be washed off.

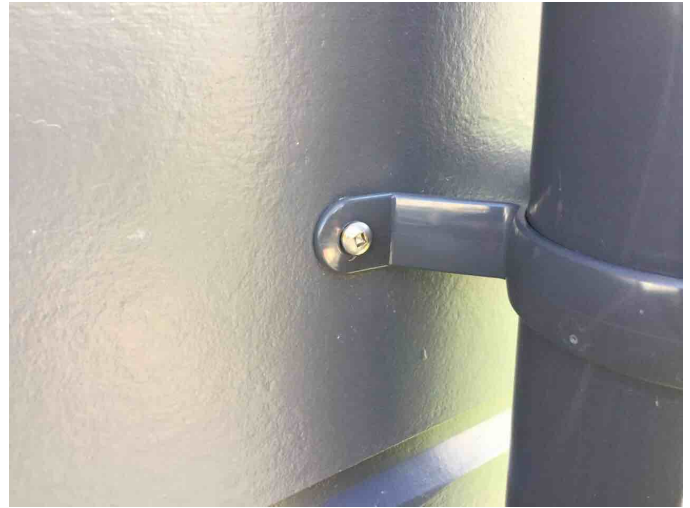
Noted stainless steel down pipe fixings have been used.

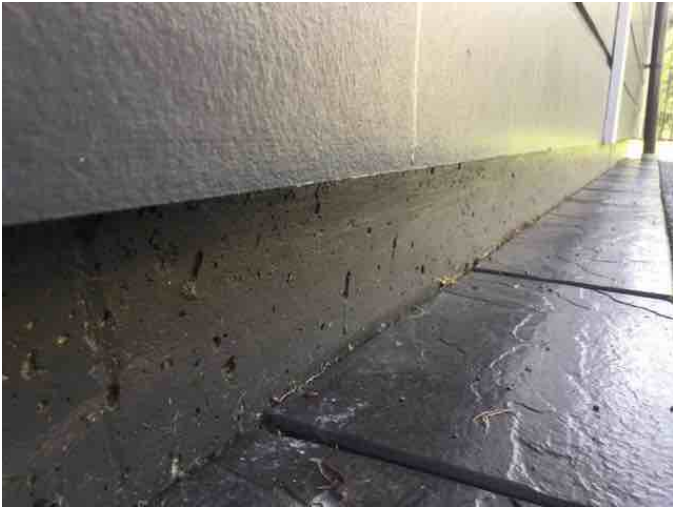
Engineered concrete ring and slab foundation.  
Commonly found in modern builds.  
No concerns sighted.

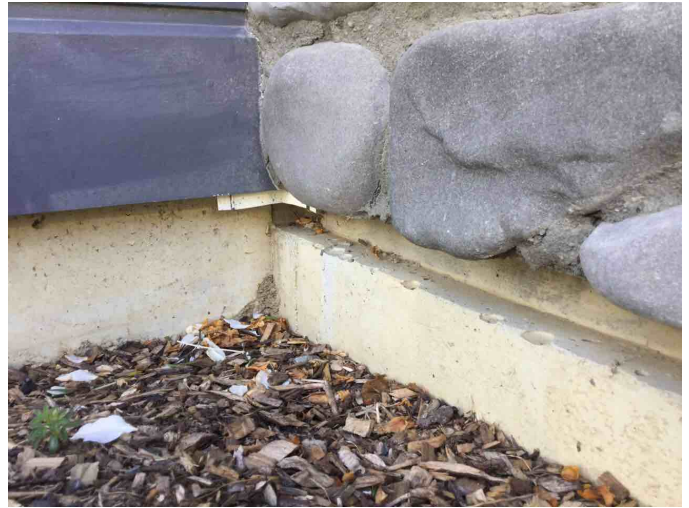
The perimeter of the foundation was sighted, no evidence of stress cracking or subsidence. No concerns.

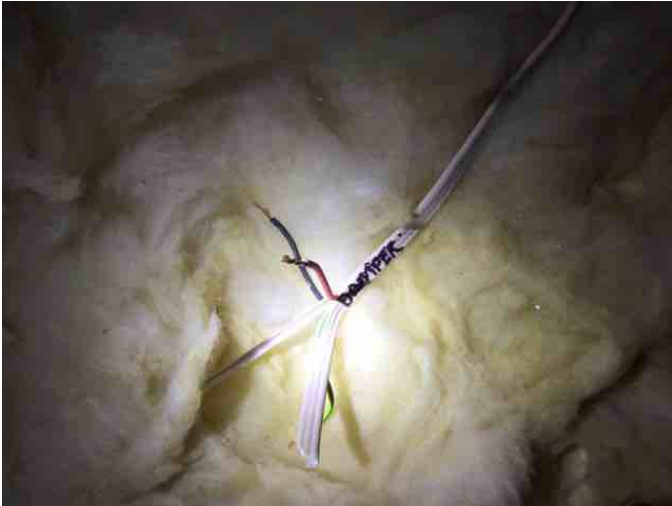
Open ended wire sighted in the ceiling cavity, unsure as to its purpose.

Recommend becoming familiar with the electrical system in the home.

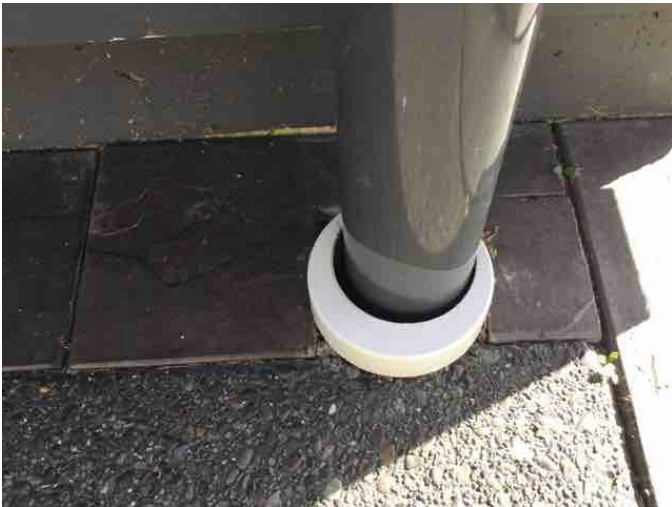
Unable to fully comment on the condition of any buried sewer drain.

No evidence of any issues at time of inspection.

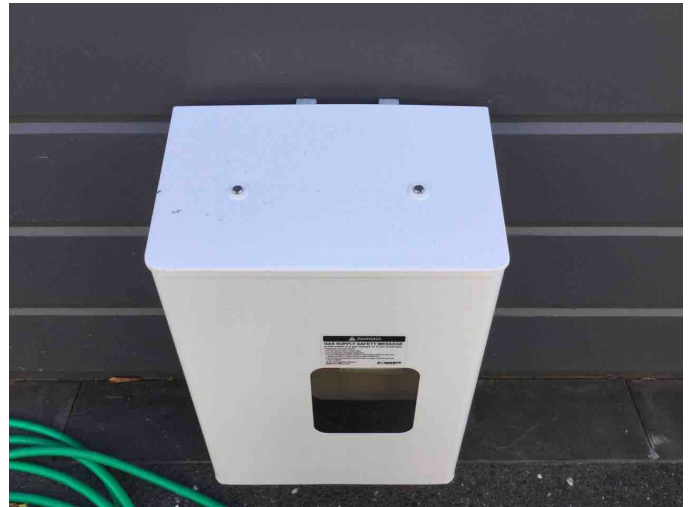
Gas meter, no concerns. Recommend sighting all gas certificates.

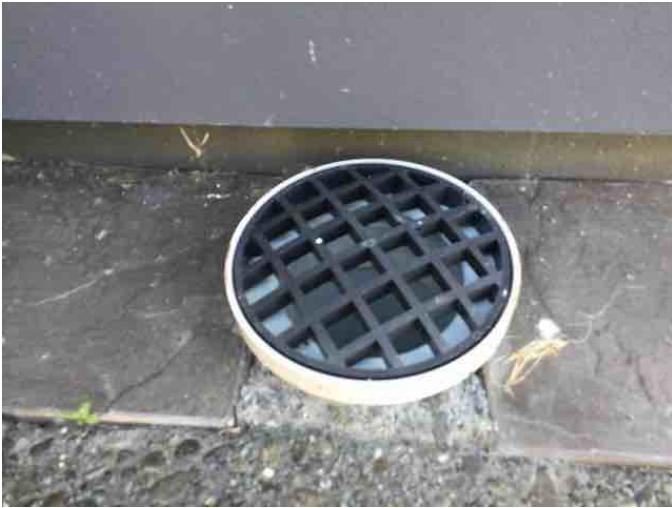
Keep gully traps clean as part of an ongoing maintenance plan

Unable to fully comment on the condition of any buried sewer drain.

No evidence of any issues at time of inspection.

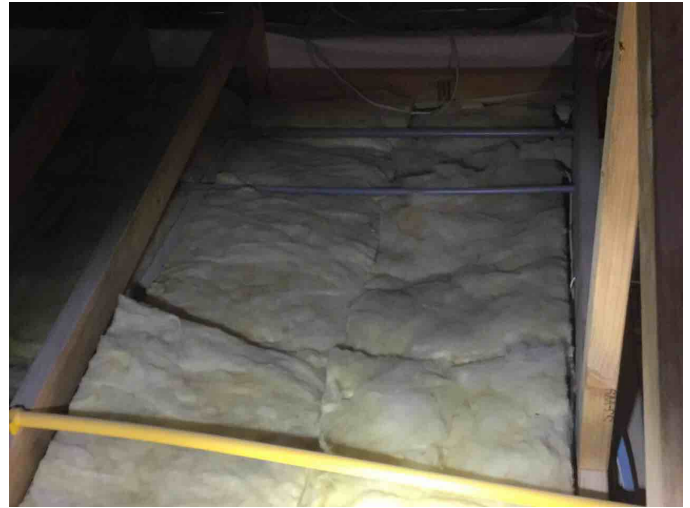
Pexal gas piping noted. Polybutylene hot and cold water noted.

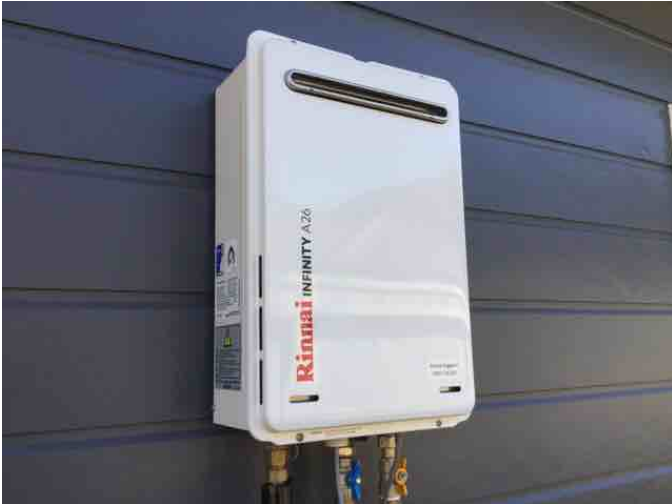
Gas instantaneous hotwater system.  
Consult vendor for any warranties and gas certificates they may have in their possession.

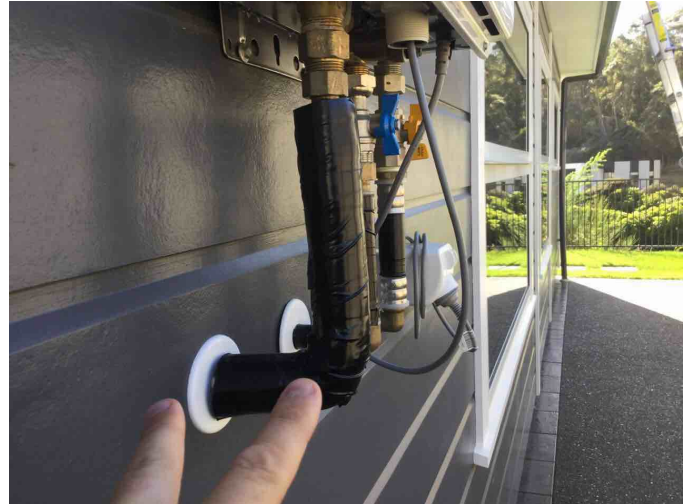
Annually inspect all penetrations, for their integrity to repel moisture ingress.

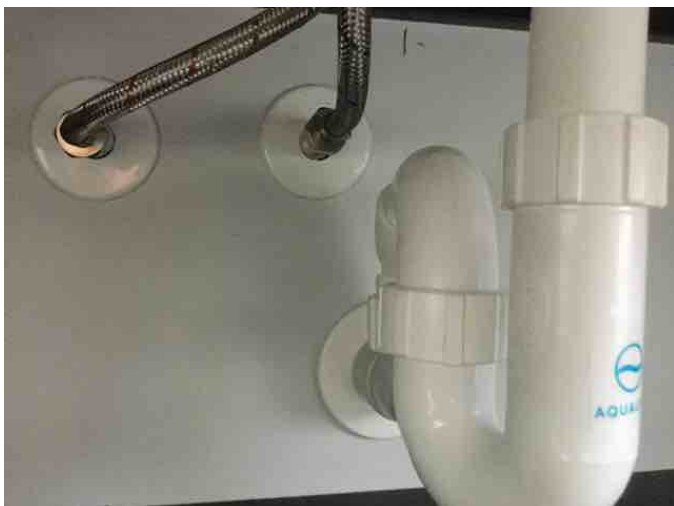
The Vanity plumbing tested ok, no concerns sighted to the plumbing or waste system connected to the sink, within the cupboard space.

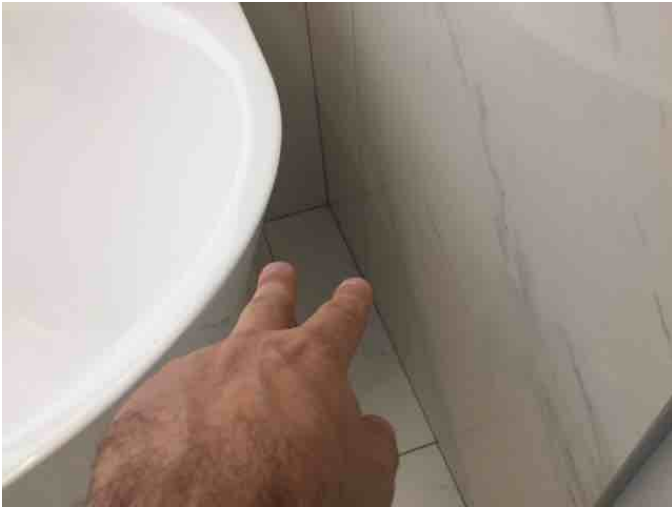
Wet area junctions well sealed.

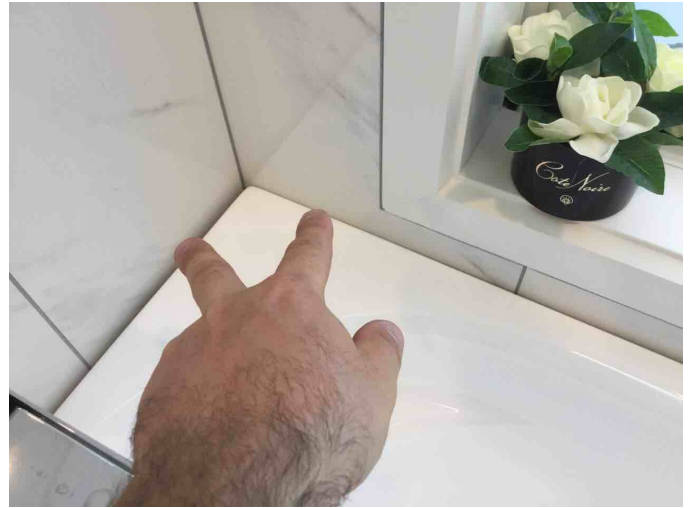
In the bath is left in situ, consideration should be given to sealing the bath against the tile to prevent water being slashed over the back lip. There is now access for mopping or cleaning.

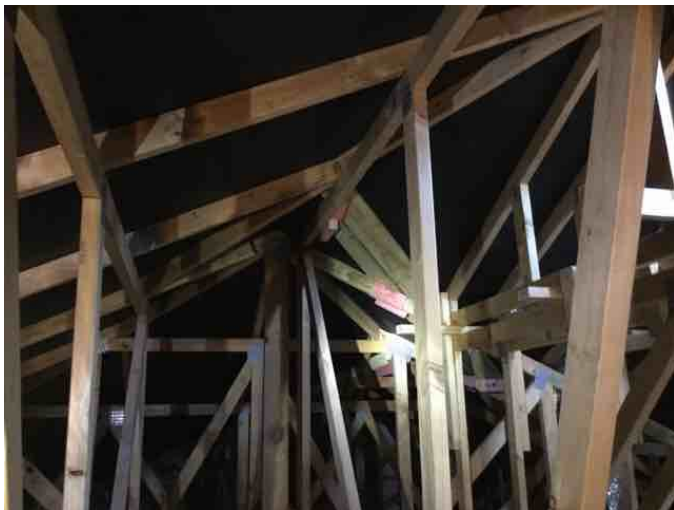
Stand up room within the ceiling.

No significant concerns.

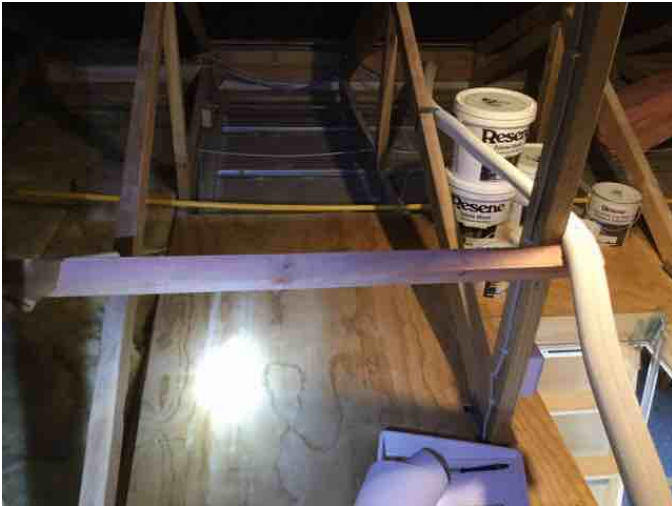
No insulation above the garage area. Not deemed a requirement by council.

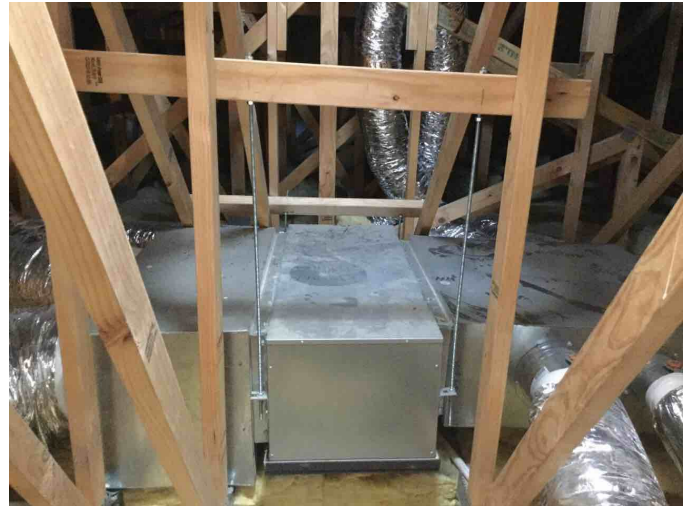
Significant ducted heatpump sighted. No concerns. Become familiar with any servicing, that may be required.

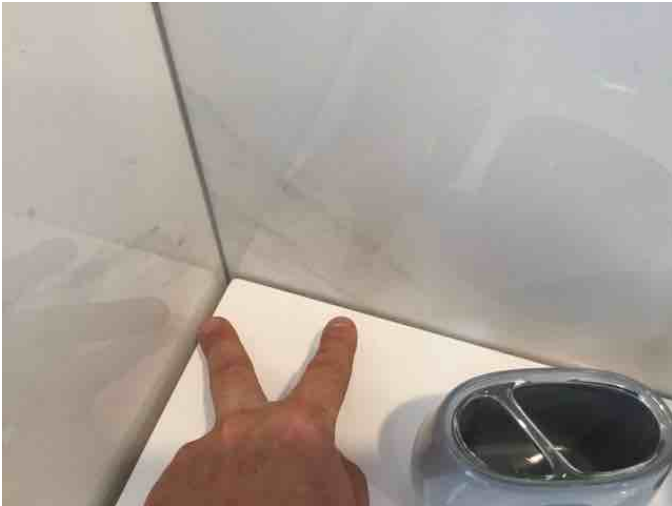
Recommend sealing the transition between the back of the vanity and the wall tile.

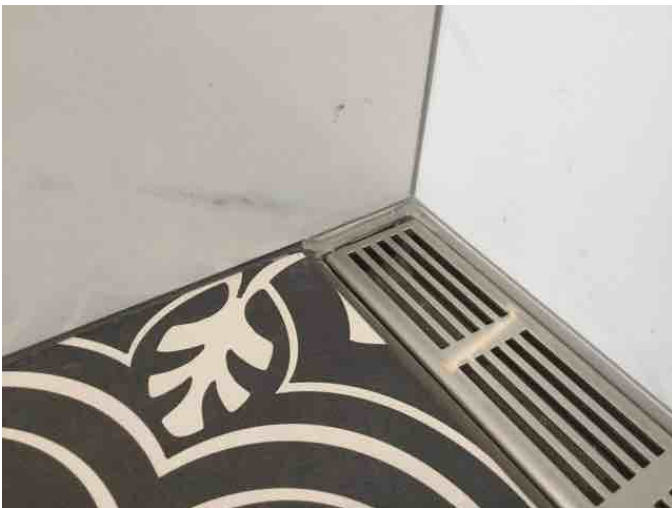
Shower well detailed.  
Recommend maintaining the silicone seals with appropriate shower cleaner, to prevent any potential mould build up.  
Consider treating to shower glass with a protective glass coating to prevent the build up of soap scum.

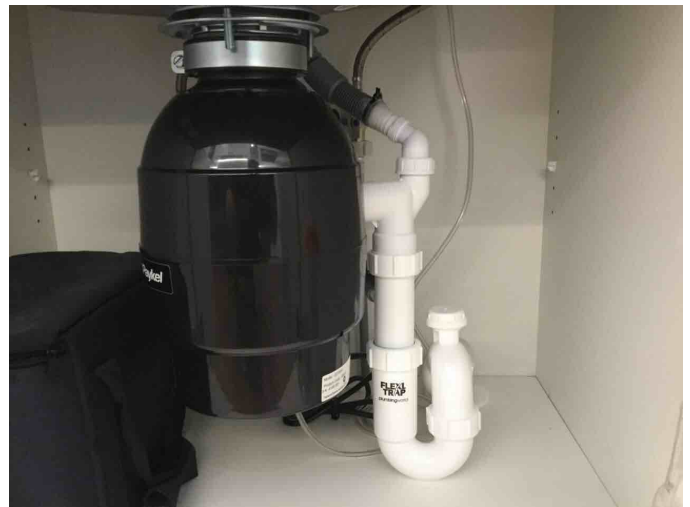
The sink plumbing tested ok, no concerns sighted to hot and cold plumbing, or waste system connected to the sink, within the cupboard space. Waste disposal wasn't working at the time of inspection.

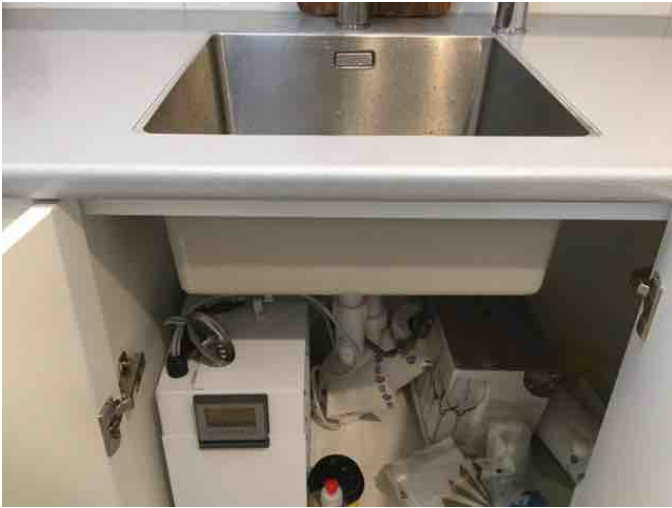
Butlers pantry. Well detailed no concerns.  
No concerns to pipe work and wastes under sink.  
Seperate undersink hotwater boiler unit noted.

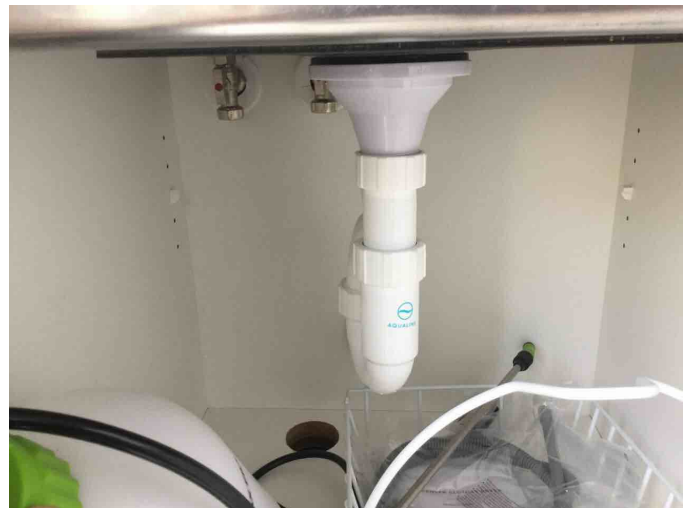
Washing machine not currently plumbed in. The Tub plumbing tested ok, no concerns sighted to the plumbing, connected to the tub, within the cupboard space.

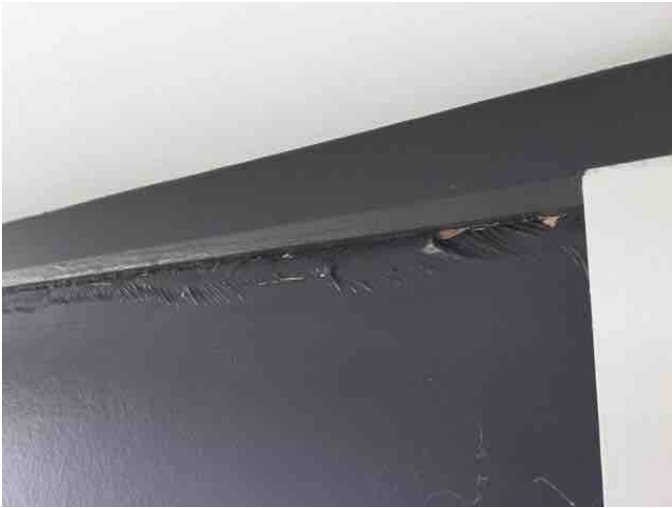
The paintcoat has significant defects adapting the timber trim / soffits

Remedial work is required to maintain the paint coat integrity.
